# STAINING OF WHITE MARBLE

V. Bams<sup>a</sup>, S. Dewaele<sup>b</sup>

*a. Belgian Building Research Institute, Belgium, [veerle.bams@bbri.be](mailto:veerle.bams@bbri.be)*

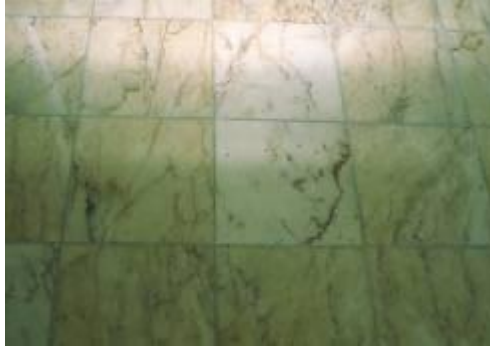
Figure 1: case of discolouration of a marble

Since the thermal shock test did not result in staining on Carrara Bianco C and this marble is actually known to be sensitive to staining (dispersed beige-brown stains in Figure 1), another staining test has been developed.

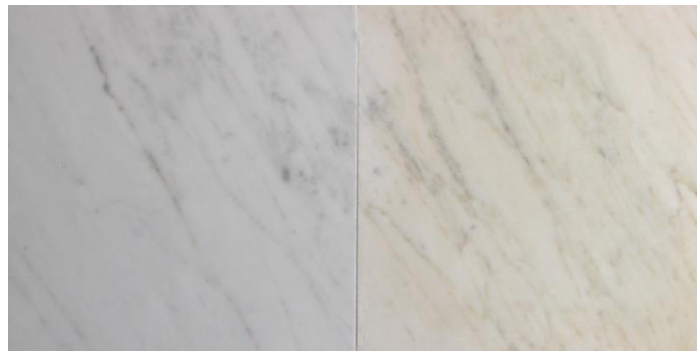
Figure 14: an Bianco Carrara C tile before the alkaline water test (left) and a tile after the test (right) (not the same tiles).

The Carrara Bianco marbles (sub-type C, C/D, D) all show a diffuse discolouration of the ground mass and the veins (Figure 14). However in a few tiles there are regions that have the same colour as before the test and no discolouration can be observed (Figure 18).

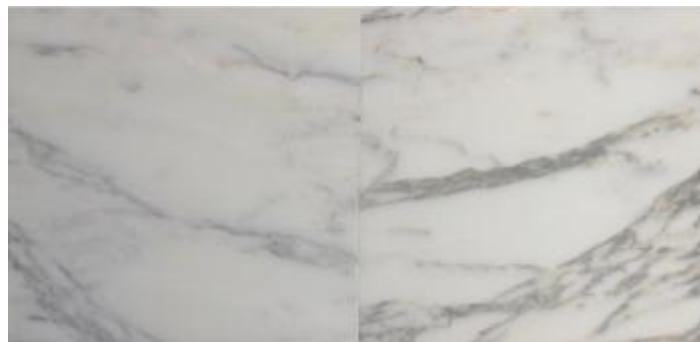
Figure 15: an Arabescato Corchia tile before the alkaline water test (left) and a tile after the test (right) (not the same tiles).

The ground mass of Arabescato Corchia demonstrate a lightly yellowish colour, but the bright white areas are not discoloured. More remarkable is the brown colour in the original dark grey veins (Figure 15), where the pyrite is concentrated.

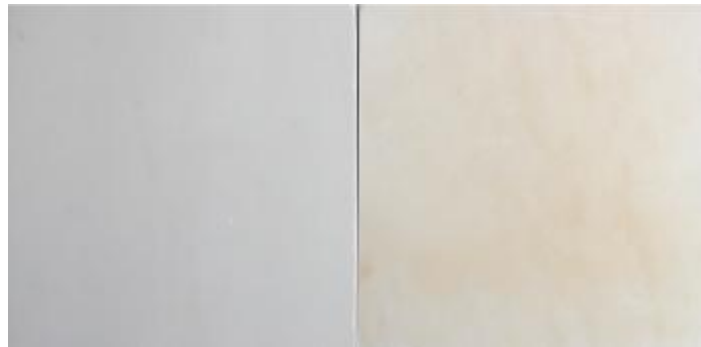
Figure 16: a Bianco P tile before the alkaline water test (left) and a tile after the test (right) (not the same tiles).

The uniformly white Bianco P marble turned into a uniformly yellow-orange marble. The whole tile shows one diffuse stain (Figure 16). In the Bianco P, pyrite is found dispersed in the ground mass of the marble. No discolouration has been observed for the Thassos White marble.

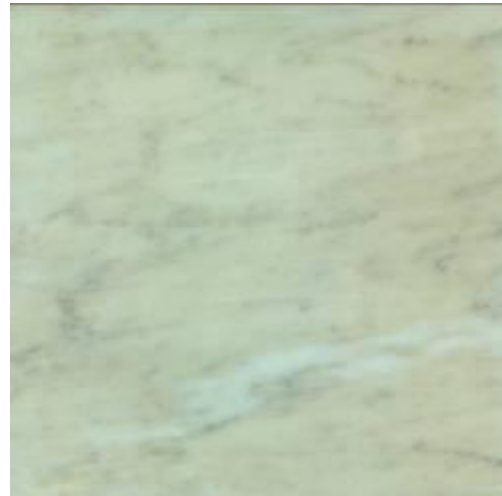
Figure 18: a Carrara Bianco C tile after the alkaline water test

The results of the test show a general yellow-brownish diffuse discolouration (example in Figure 18), visually homogeneously spread on the surface. Chromatically, this discolouration is characterised by a shift between the pics of the red and blue channels (Figures 19 and 20), the distribution of the green channel remaining unchanged.

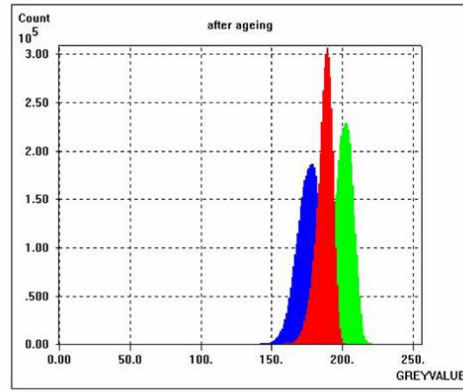
Figure 20: RGB distribution of the same Carrara Bianco C tile after the alkaline water test

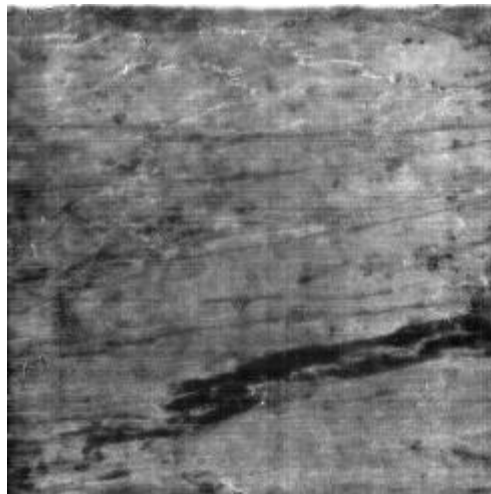
Figure 21: Distribution of the  $\Delta E_{lab}$  values related to Figures 17 and 18.

In order to map the quantitative colour variation of each pixel before and after the test, the calibrated RGB values have been transformed into a L\*a\*b system, which allows the calculation of the difference between two measured colours according to the following relationship:

With L the value of brightness, a and b the values of respectively the red-green saturation and the yellow-blue saturation.  $(\Delta L^*)$ ,  $(\Delta a^*)$  and  $(\Delta b^*)$  in Equation 1 are the pixel-to-pixel differences within each of the L\*, a\*, b\* channels before and after the oxidation test. This result is then mapped into a new image (Figure 21), in which the intensity of each pixel is proportional to the calculated  $\Delta E_{lab}$  (black colour corresponds to zero and white colour to the maximum).
